Thermal Performance of External Renders Applied to Concrete Blockwork

Andrew Sapienza¹, Alex Torpiano² & Vincent Buhagiar³

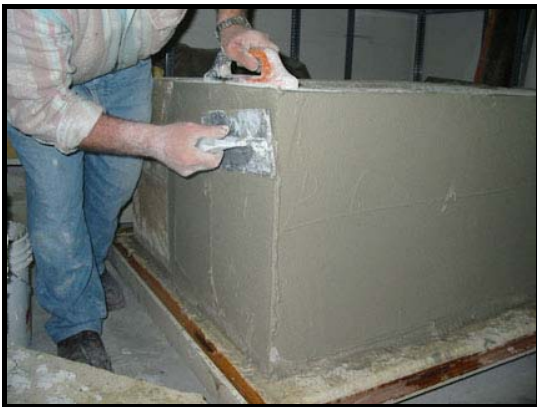
P1 – pre-mixed cement base mortar. This is the most popular render and, since it is pre-packed, it ensures speed in carrying out the work, with guaranteed results and constant quality on site. This render is usually applied at 6–7mm in thickness. Also, polymer-based resin additives may be added to the mix, to achieve different qualities required, such as waterproofing or increased elasticity.

Fig1: P1, sand and cement mix

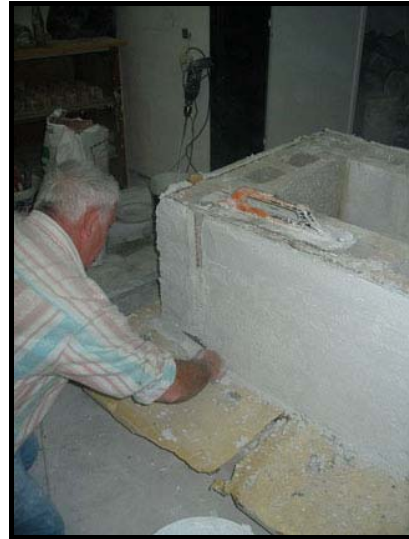
P2 – this render is said to be an ‘*advanced-technology dehumidifier*’ because of its macroporous structure, the render also has low thermal conductivity, thus improving the thermal insulation of masonry. This render can be applied in layers of up to 25mm thickness for maximum insulation efficiency.

Fig2: P2, macroporous mix

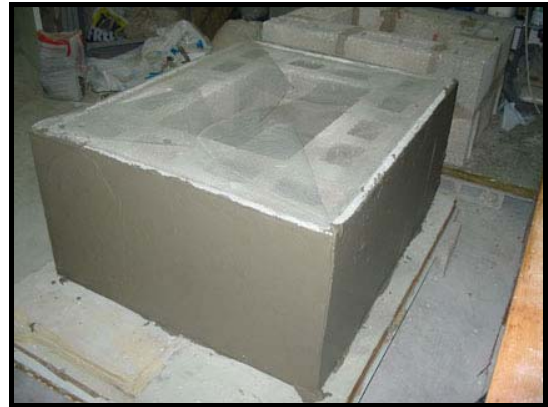
P3 – this system consists of a smooth finish adhesive, polystyrene foam and glass fibre mesh covered again by the smooth finish adhesive. A final finish coating is applied over this system. This thermally-insulated façade system can offer many advantages, apart from offering a very fast way of thermally insulating a building. As a result, the interior face of the wall does not cool down much, stopping unwanted condensation, dampness and mould.

Fig 3: P3, polystyrene and glass fibre structure

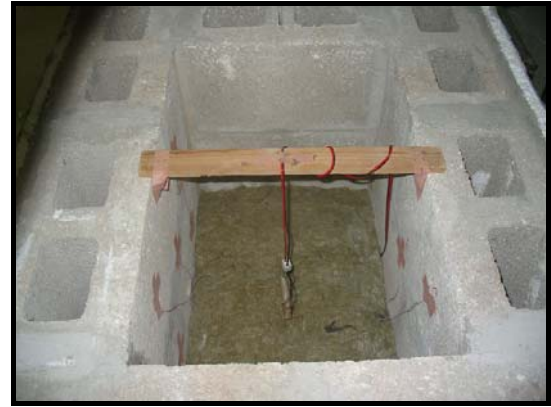
Fig 4: Thermocouples fixed into position on 'hot' face

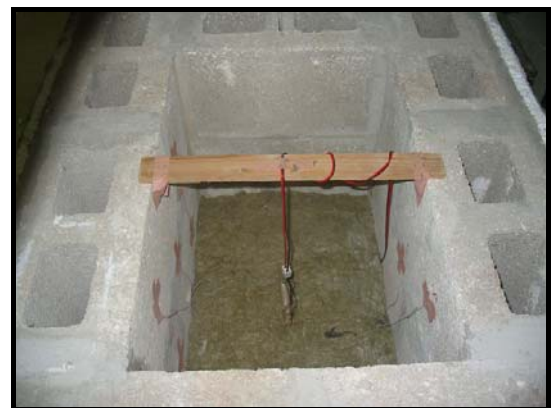
Two 10mm diameter holes were dug through the base insulation, to allow the passage of the thermocouple wires, as well as the wires leading to the resistors and light bulb, from the inside to the outside of the cell. The two holes were dug as distant from one another as possible so the higher voltage passing through the wires leading to the resistors would in no way interfere with the milli-volts passing through the thermocouple wires. A higher voltage passing close to the thermocouple wires, could affect the voltage induced with the wire, and therefore a wrong reading may result or different readings may be read for the same temperature.

Fig 5: Thermocouples fixed into position on 'hot' face

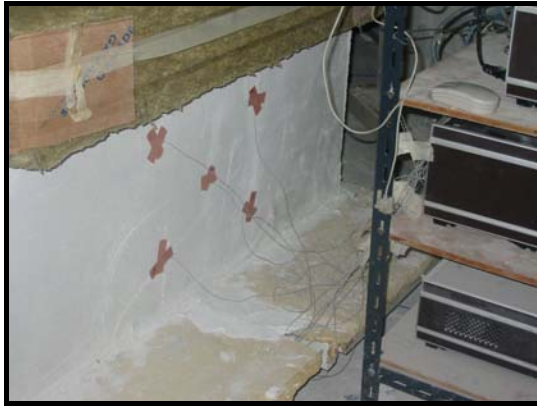
Each thermocouple was clearly labelled according to its assigned channel to avoid confusion when moving the sensors from one cell to another. This also easily helped to identify which sensor may be defective in case of abnormal readings.

Fig 6: Thermocouples labelled according to their respective channels and connected to data logger

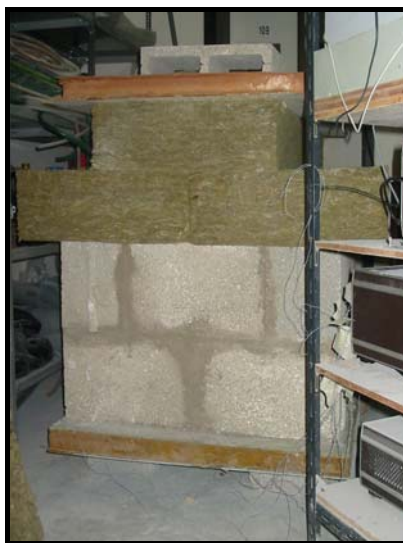
Great care was taken to ensure that heat loss from the inside of the cell was minimal from the top or bottom of the cell. This was to ensure that heat could flow laterally through the concrete block and render. The cell was built raised off the ground and on an insulation panel 120mm thick. The insulation panel and the air beneath the panel provided an insulation barrier.

Fig 7: Cell sandwiched between insulation

Four cells were built from the concrete blocks provided. These measured 1150mm x 920 x 520mm. These were built on insulation panels 120mm thick, and elevated from the ground to ensure a good insulation barrier beneath the cell. The top of the cell was roofed with 300mm thick insulation mineral fibre insulation(Rockwool©) to minimise heat losses from the top. The internal face of the cell was left bare and the external face was applied with the different types of renders. In this way, since the top and bottom of the cell were well insulated, heat only flowed laterally through the concrete brick walls and render to the outside.
